JOINT HIGHWAY RESEARCH PROJECT

JHRP-75-18

WARRANTS FOR LOCATION AND
DESIGN OF LOCAL SERVICE ROADS

Final Report

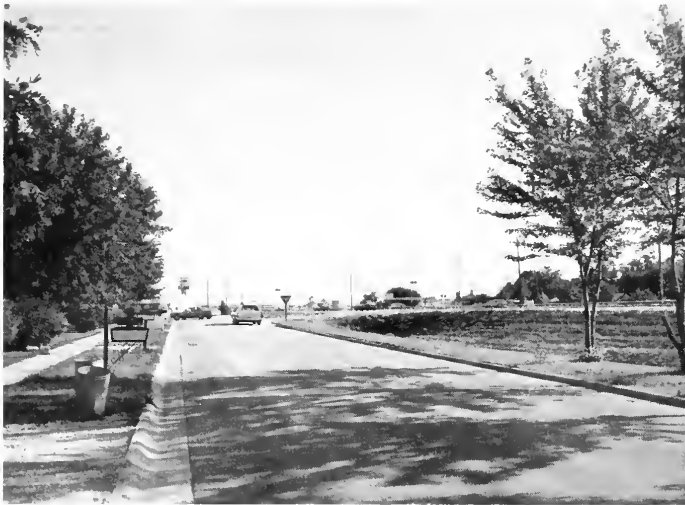
Figure 4. A Typical Three-Legged LSR Intersection at a Highway Access Point

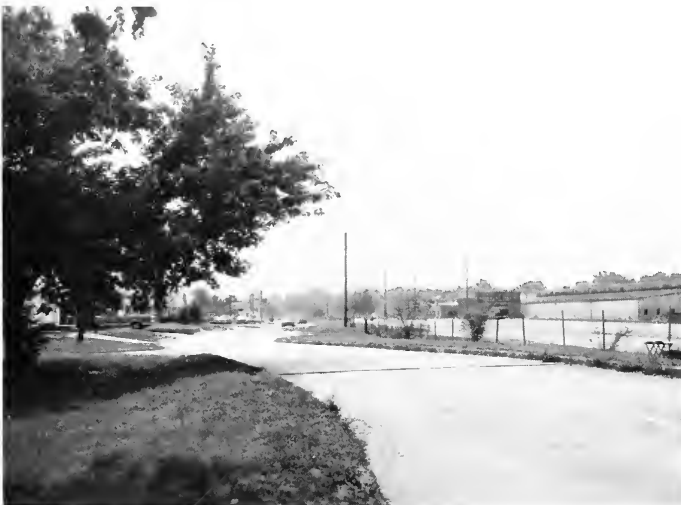
Figure 5. The Reverse Curve of this Three-Legged LSR Intersection May Have Contributed to Two Accidents

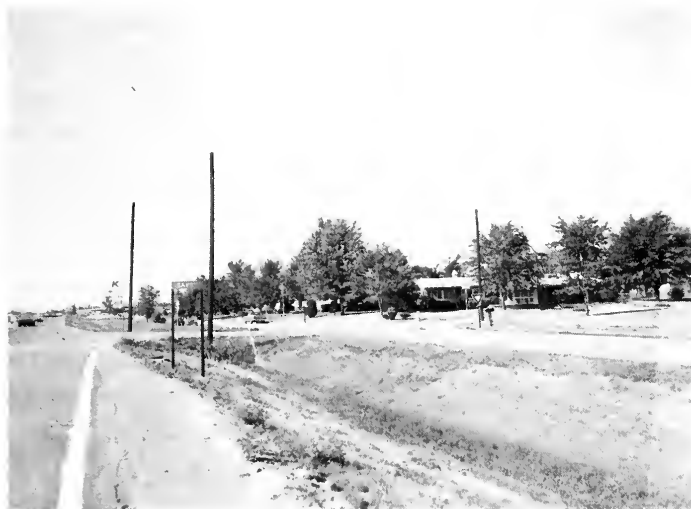
Figure 7. A Typical Four-Legged Intersection
of an LSR with a Crossroad

Out of the eleven intersections grouped in Type B (see Figure 7) six had no recorded accidents. Two other intersections of the Type B configuration which were not used in the conflict analysis also had an accident history. Thus a total of thirteen four-legged LSR sites were considered for their accident patterns, five at uncontrolled intersections, eight

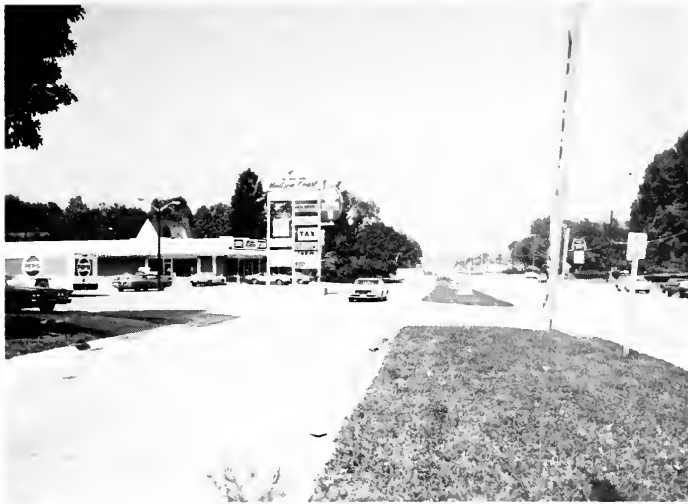
Figure 8. A Four-Legged LSR Intersection Where Two Right-Angle Accidents Occurred

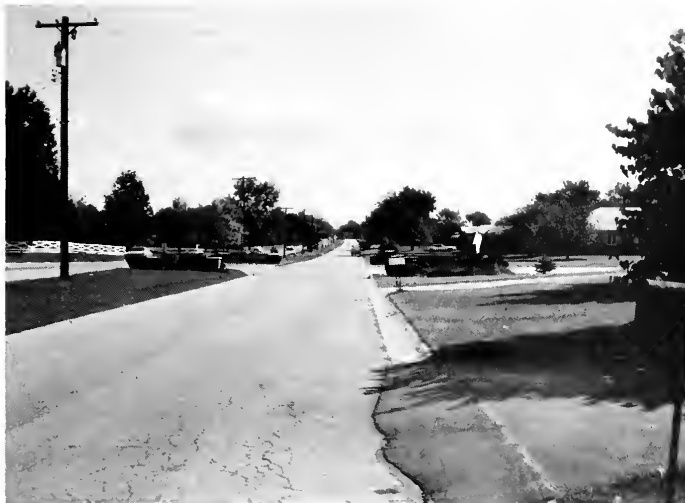
Figure 11. The Brick Planters at this Location Limit Driver Visibility at the Intersection

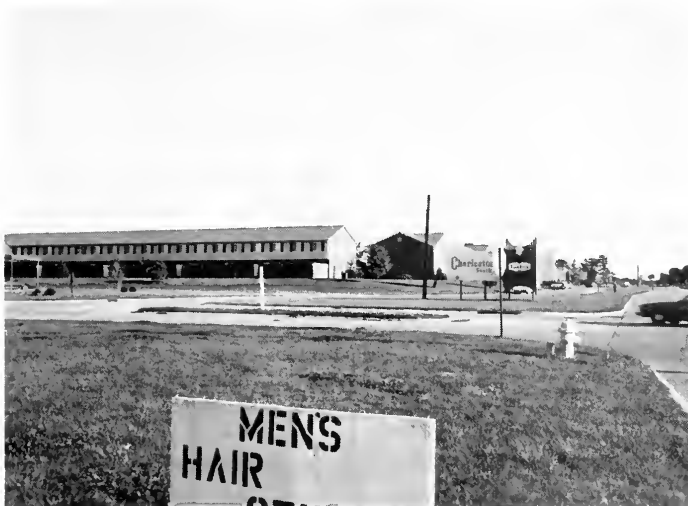
Figure 23. This LSR Is Curved to Achieve a Greater Width of Separation at Its Terminal Intersection with the Crossroad

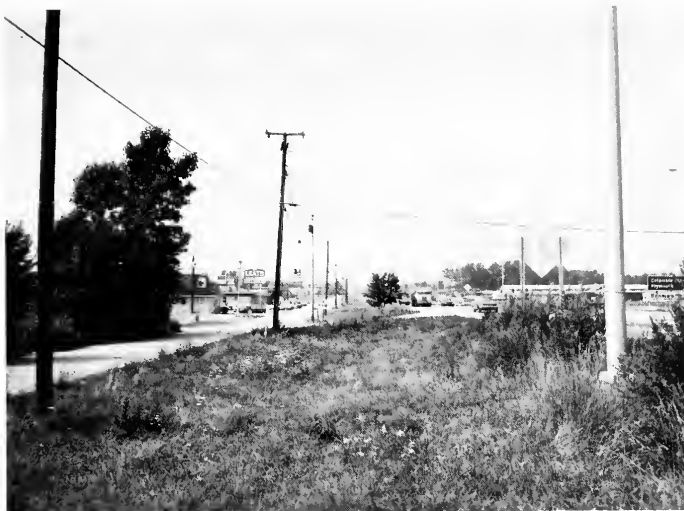
Figure 30. The Tree and Steep Grade of this Access Approach to the Highway May Have Contributed to Some Accidents at this Intersection

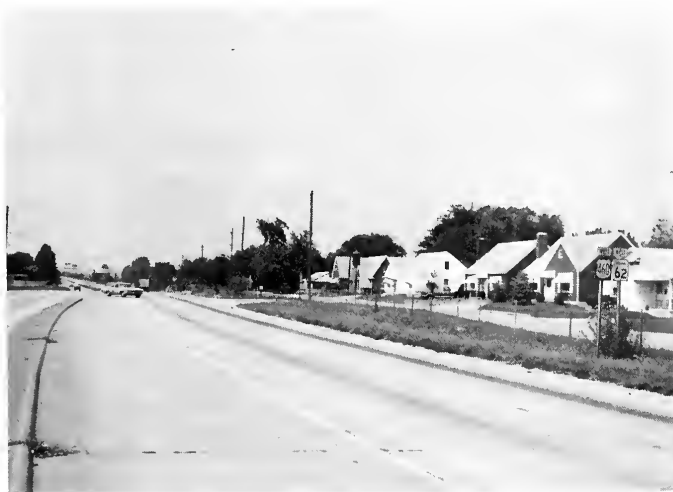
Figure 33. Vehicles Stopping for the Service Road Adjacent to this Four-Legged Highway Intersection May Cause Difficulties to Vehicles Entering the Access Point

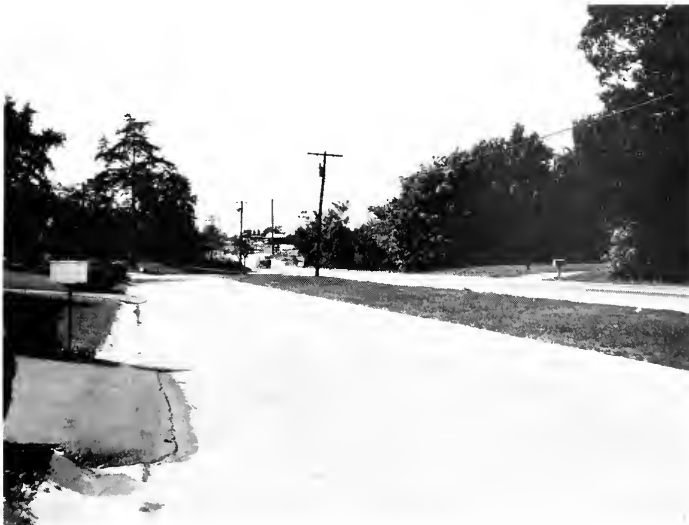
Figure 37. A Three-Legged Highway Intersection Where a Local Service Road Terminates

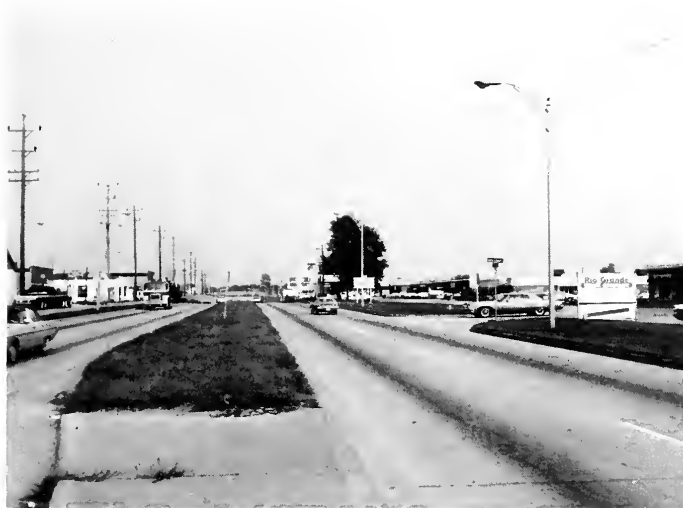
Figure 38. A Typical Highway Intersection Where the Local Service Road Access Point Has No Median Crossover

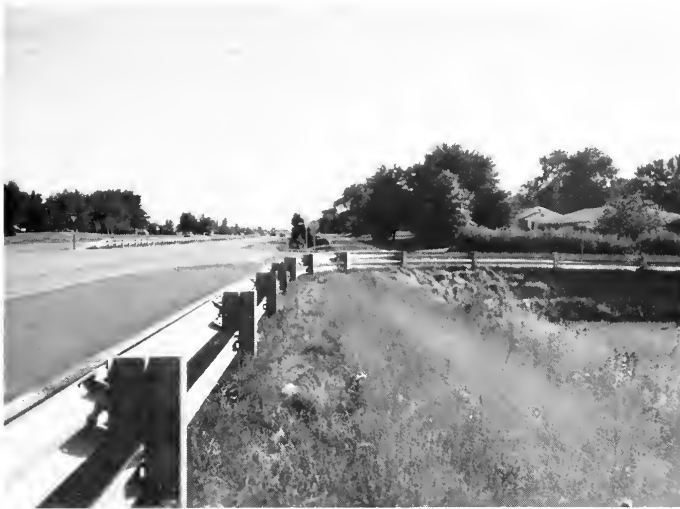
Figure 41. A Typical Four-Legged Highway Intersection, the Fourth Leg to the Left of the Picture, Where an LSR Terminates at the Crossroad

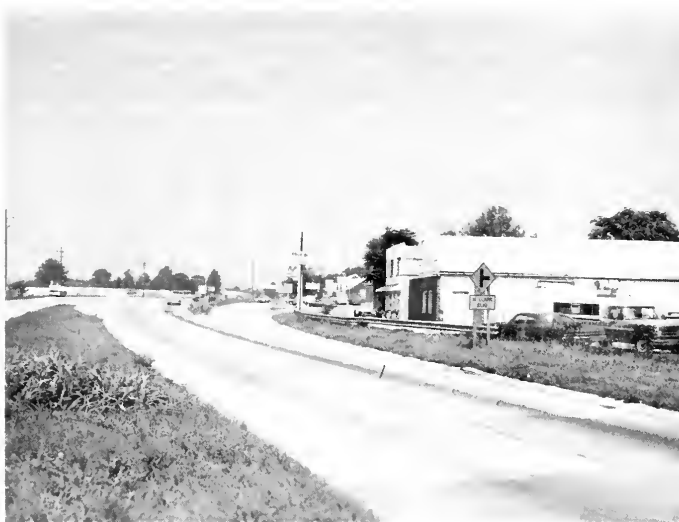
Figure 47. A Low-Angle Diverge Point of Entrance into a Service Road
